HISTORIC STRUCTURE REPORT

Thomas H. Moore House
2201 Dixie Avenue SE, Cobb County
Smyrna, Georgia 30080-1578

Prepared for: Joel Powell, Property Owner
Prepared by: Conservation of Historic Building Materials Class
Georgia State University, Fall 2013

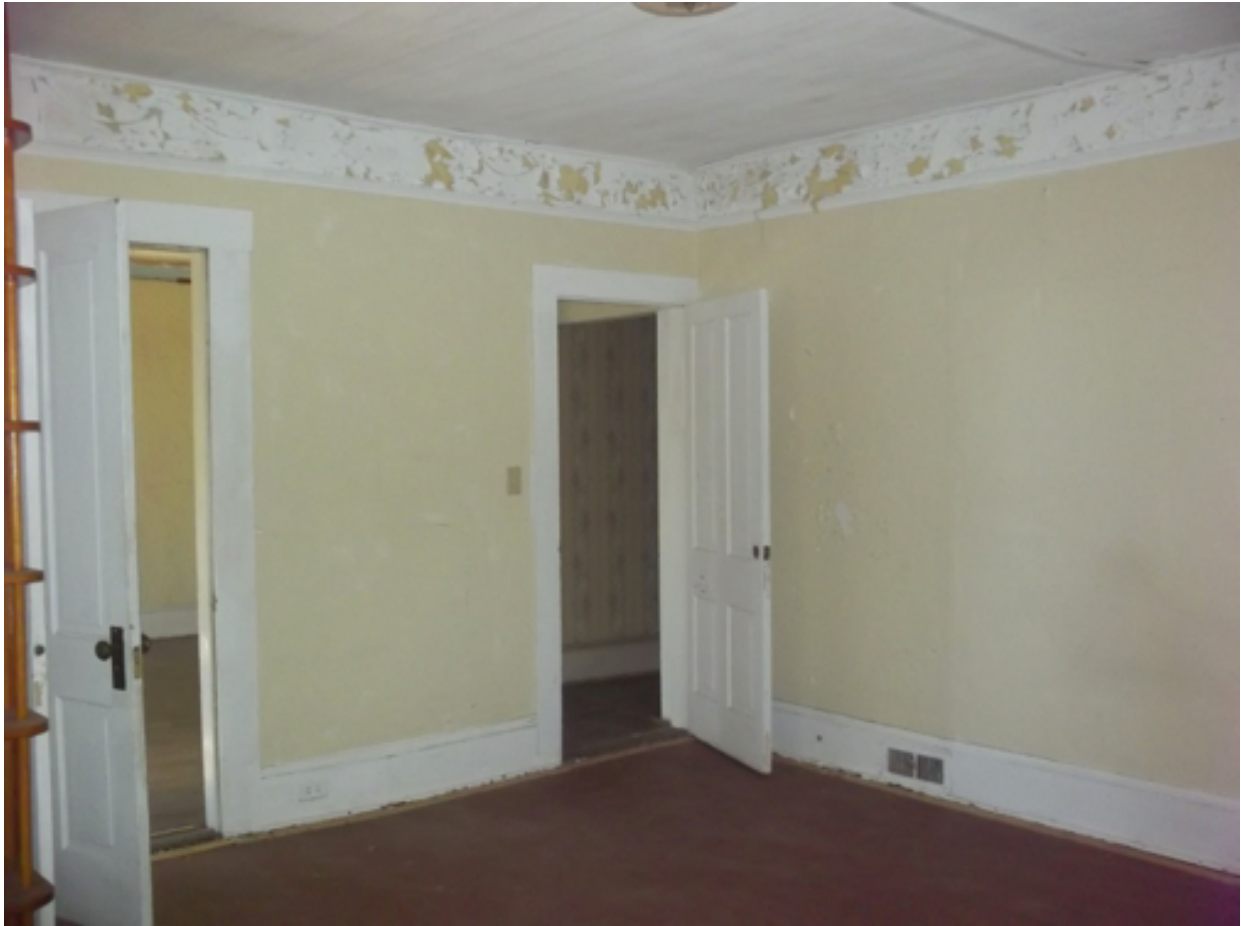
Figure 4.45: Northwest corner of Room 205, note moisture damage between the picture moulding and the ceiling.

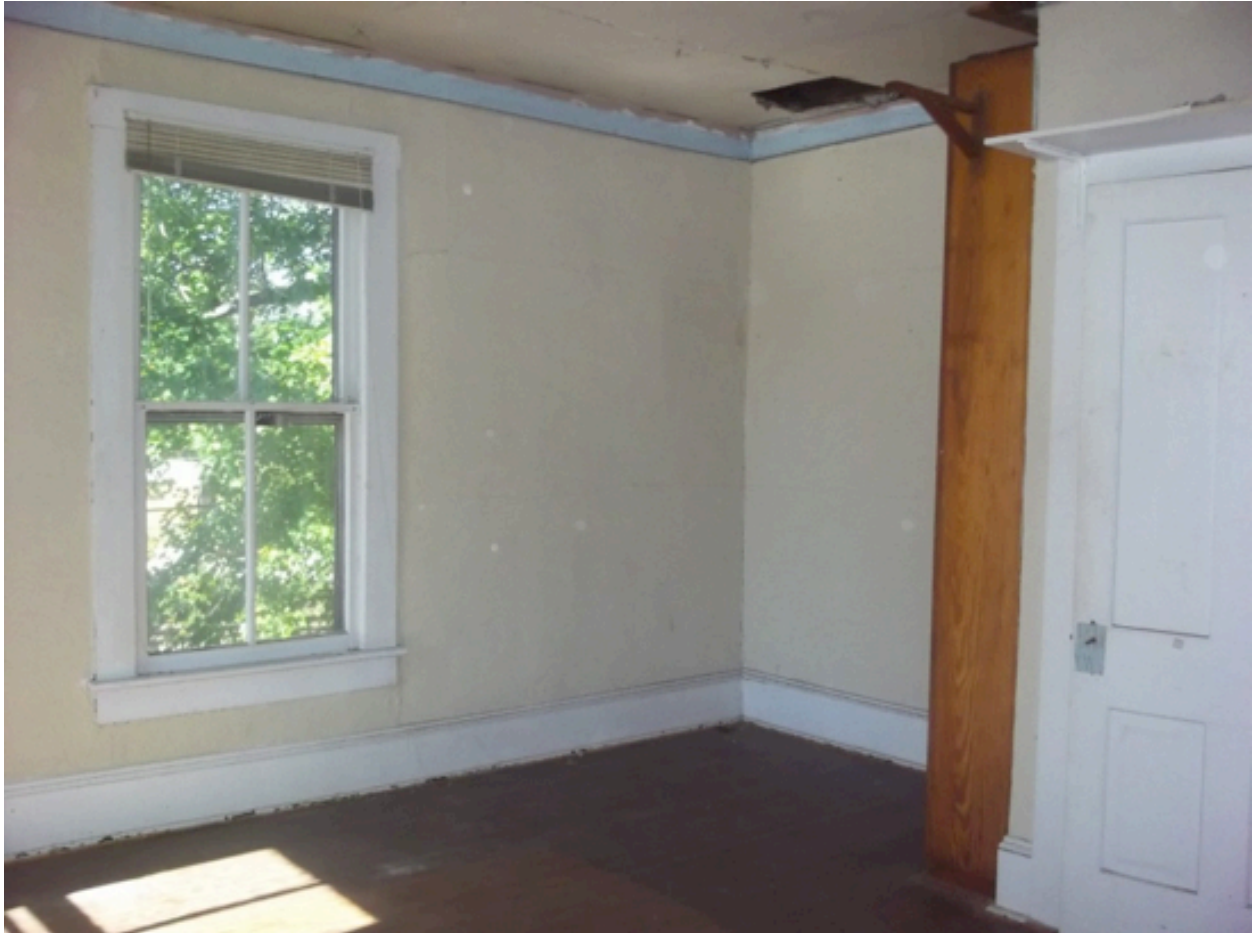
Figure 4.46: Northwest corner of Room 206, depicting damage to the ceiling caused by installation of a drop ceiling.

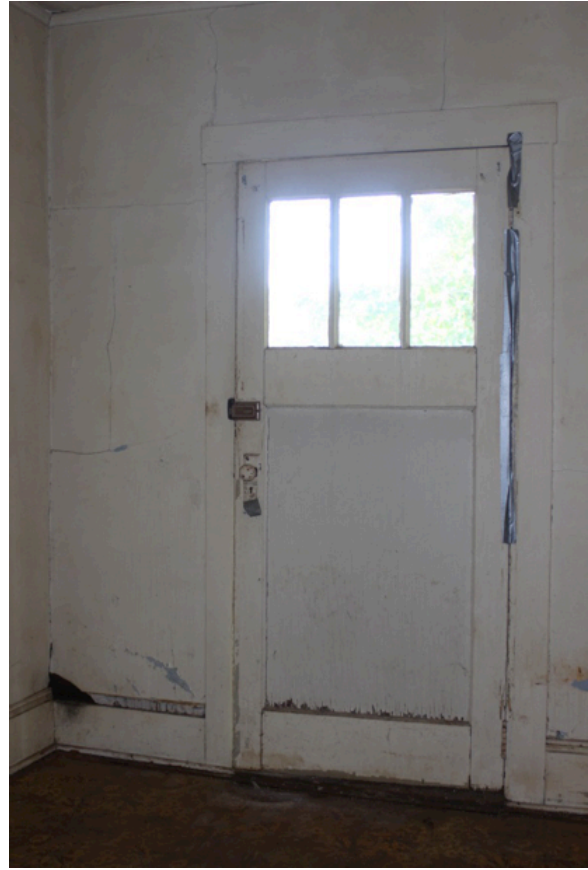
Figure 4.48: Southwest corner of Room 207, depicting wall damage.

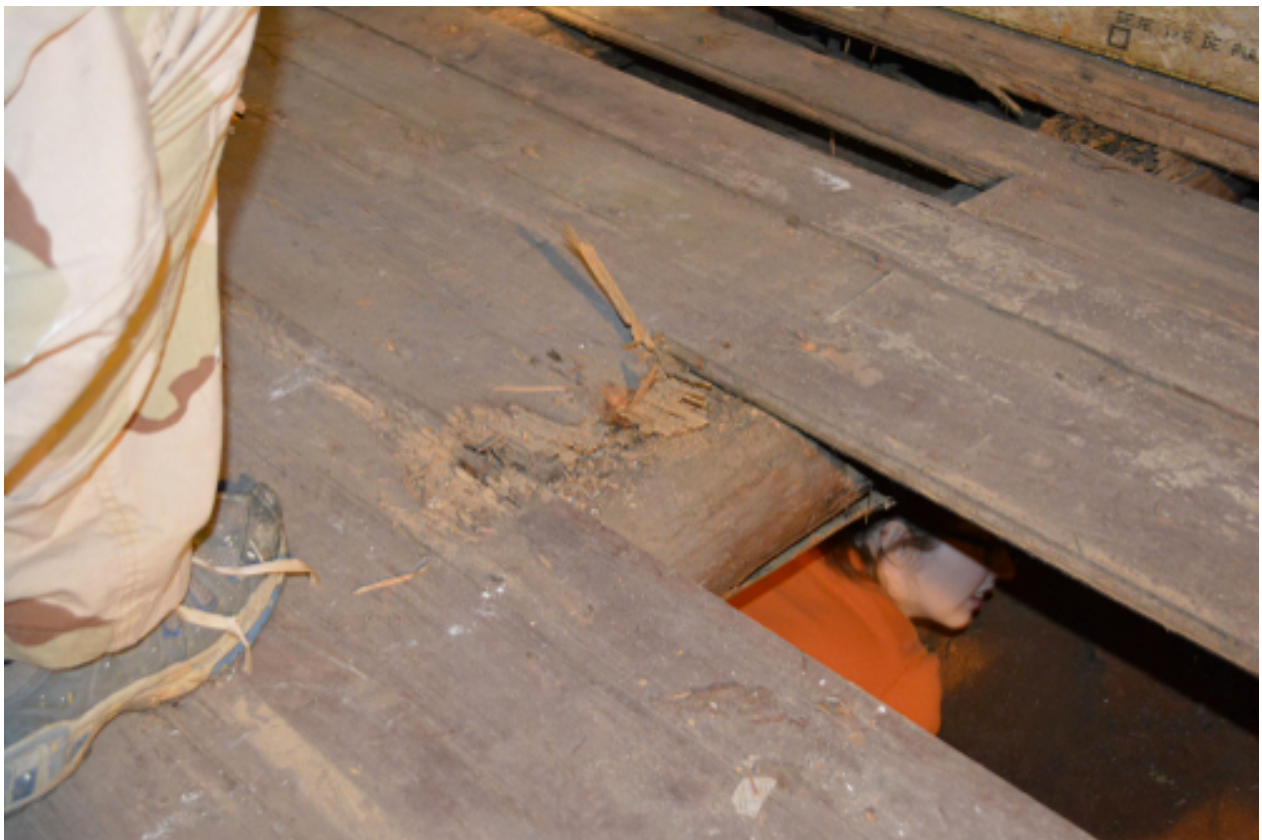
Figure 4.49: Room 101 showing deteriorating floor boards due termite damage and negligence.

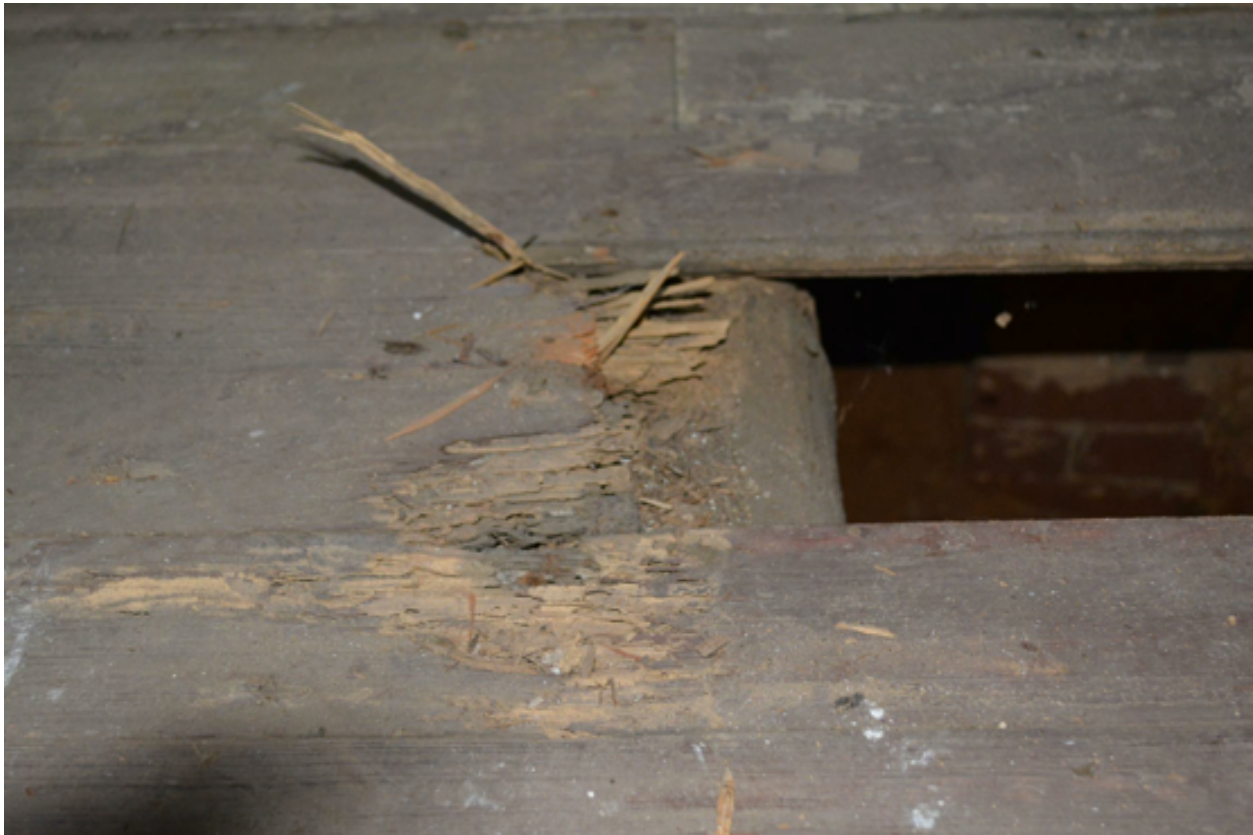
Figure 4.50: Room 101 close-up of deteriorating floor boards showing tunnels made by termites.

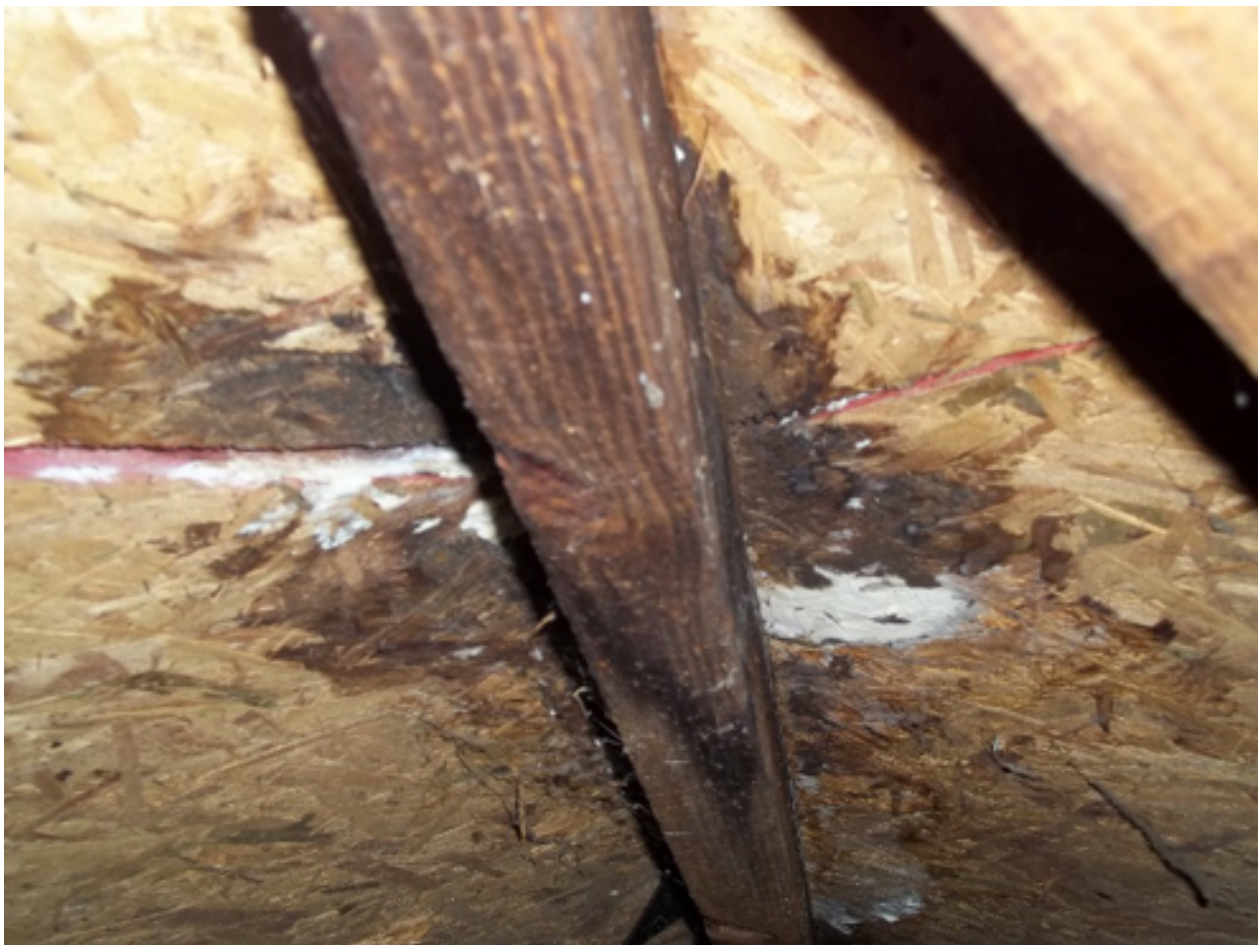
Figure 4.51: Holes in parts of the roof have allowed rainwater in, creating a moist environment allowing white and black rot growth.

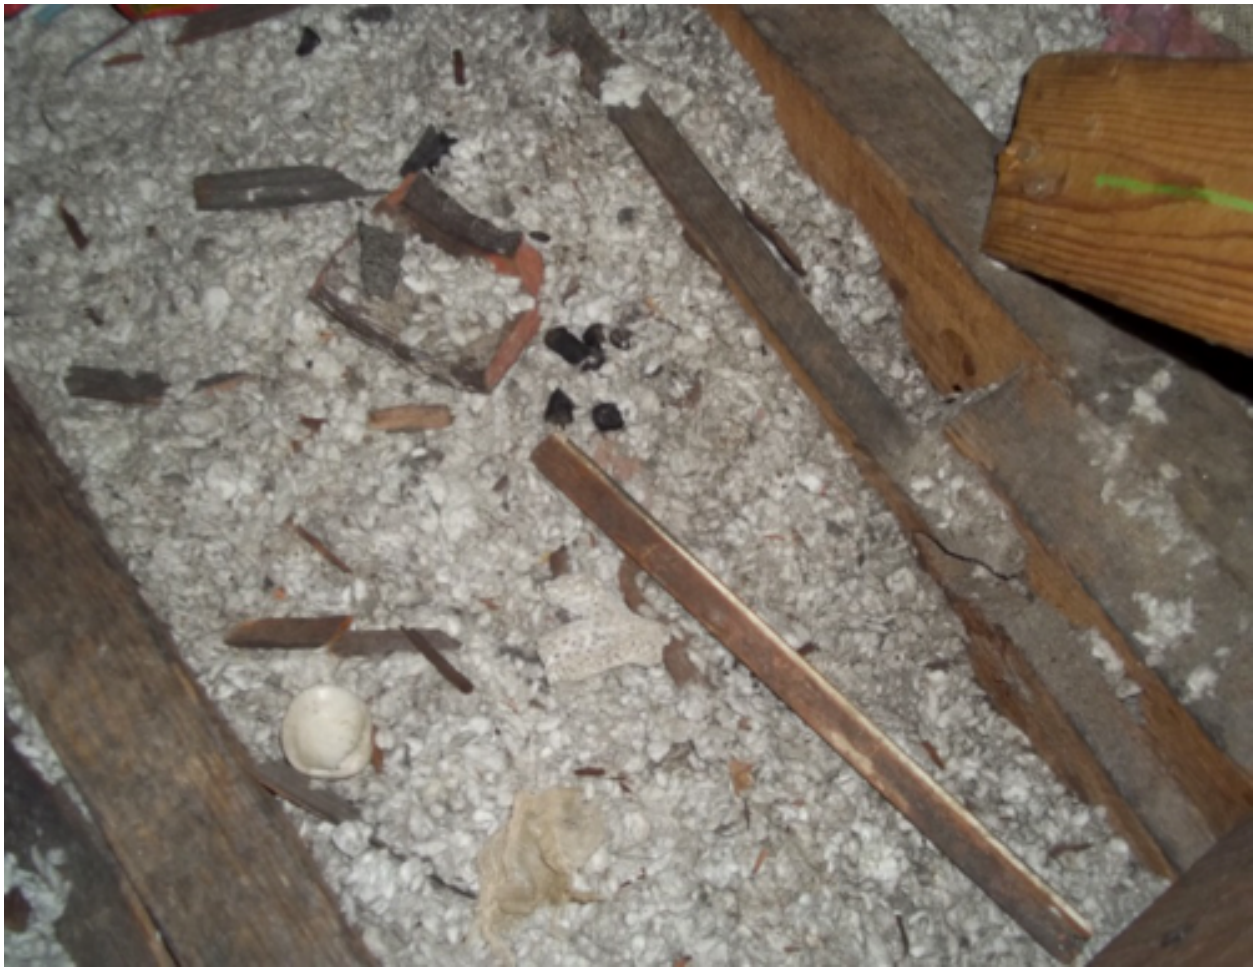
Figure 4.52: Evidence of animal fecal matter in attic as well as hazardous crumbling particles and debris..
